# Appendix 1: Submission by Knights 22.10.2021

**Ingersley Vale Mill - Comments by Knights plc on Behalf of H. Cumberbirch**

**STRUCTURAL INSPECTION OF  
INGERSLEY CLOUGH MILL  
INGERSLEY VALE  
BOLLINGTON  
APRIL 2019**

Bell Munro Consulting Ltd.  
Consulting Civil and Structural Engineers  
Turing House  
5 Archway  
Manchester  
M15 5RL  
Tel: 0161 2098032  
Fax: 0161 2098033  
E-Mail: [consulting@bellmunro.co.uk](mailto:consulting@bellmunro.co.uk)  
Ref: J6037.B

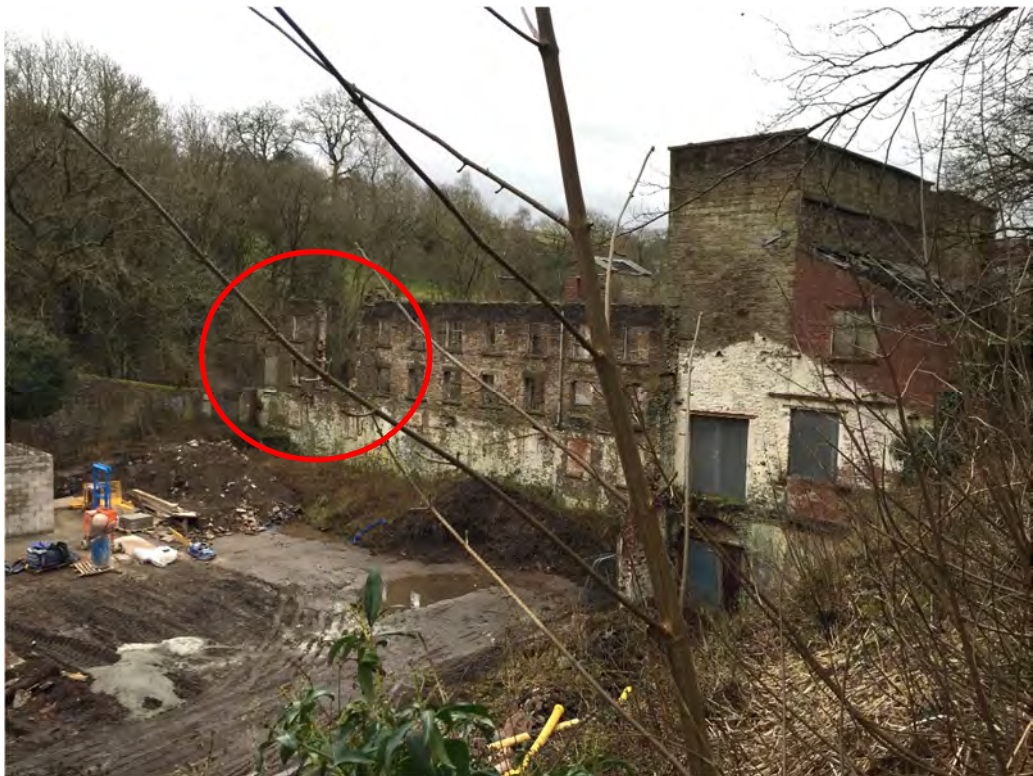
**Photo 1 (image taken on 10 March 2021)**

- (b) Since the submission of the structural engineers report dated April 2019, there has been further collapse to the northern elevation as identified by the red outline on photo 1 below, which confirms the views of the structural engineers acting for both parties.

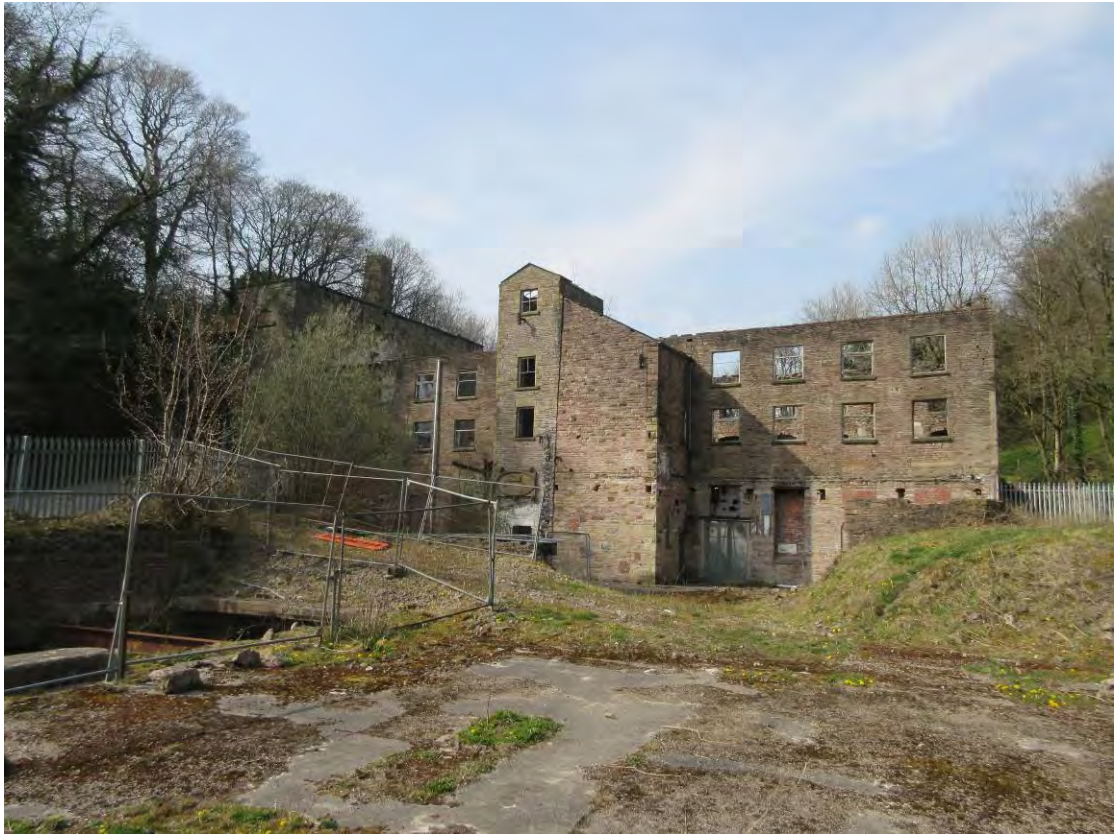
- 2.03 A structural inspection of the South elevation was undertaken and significant movement of the stone wall structure to the main wall to the elevation was evident. Lateral movement and bowing was noted together with significant vertical displacement of the stone structure and failed stone lintels. Movement of the rubble fill to the wall was suspected together with significant weathering of the exposed wall head. Brick infill panels had been installed in several low level openings at some point in the past. The section of the South elevation at the West side of the elevation spanned over a watercourse and appeared to be supported by a stone arch structure. Significant movement of the stone wall structure above the arch was evident.

A.1 South Elevation of Building

- 4.01 It is recommended due to the unstable state of the wall structures and the impracticalities of undertaking a safe repair that the North and South walls and what remains of the East gable to the main building are taken down and rebuilt. Given the poor condition of the remaining sections of these walls it is recommended the taking down and rebuilding works are undertaken as soon as possible. Further deterioration of the walls would reduce the possibility of the works being undertaken in a controlled manner and therefore the possibility of salvaging the stone and features.
- 4.02 It is likely the wheelhouse structure could be safely repaired although a detailed assessment of the retaining structure adjacent to the watercourse will be required as this may require strengthening or repair works.

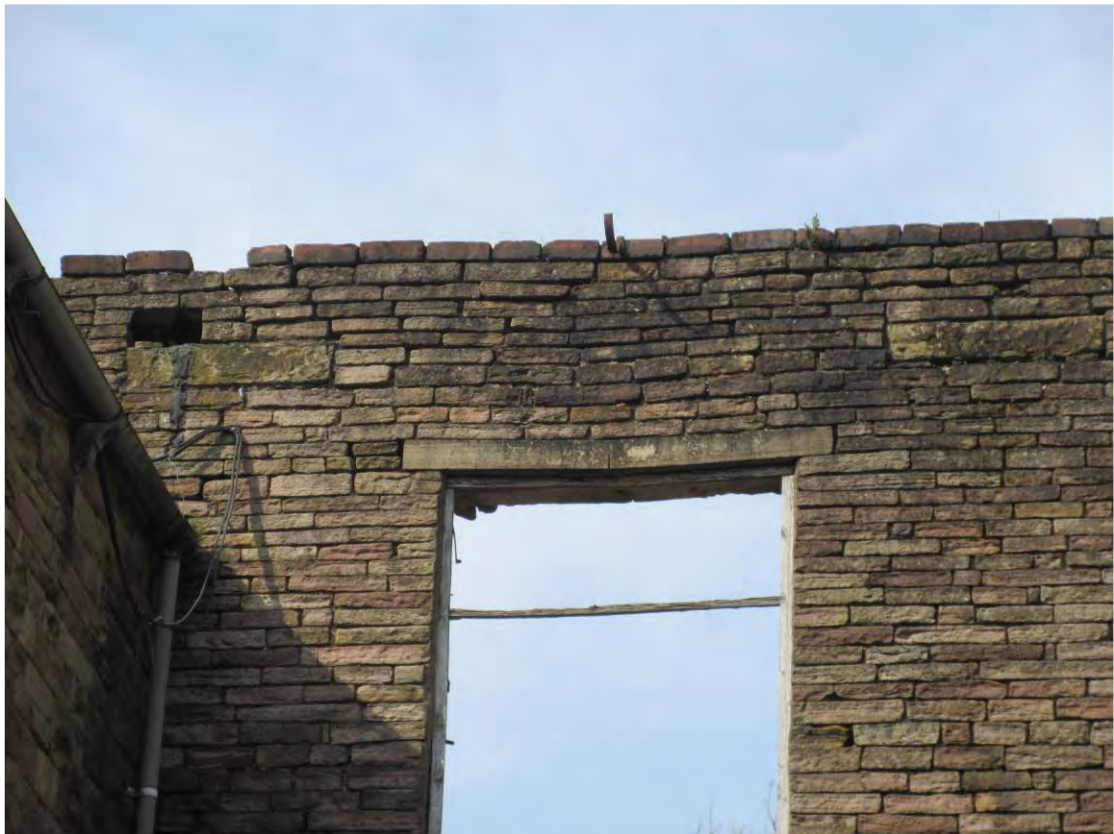
A.2 Fractured Lintel and Unstable Stonework

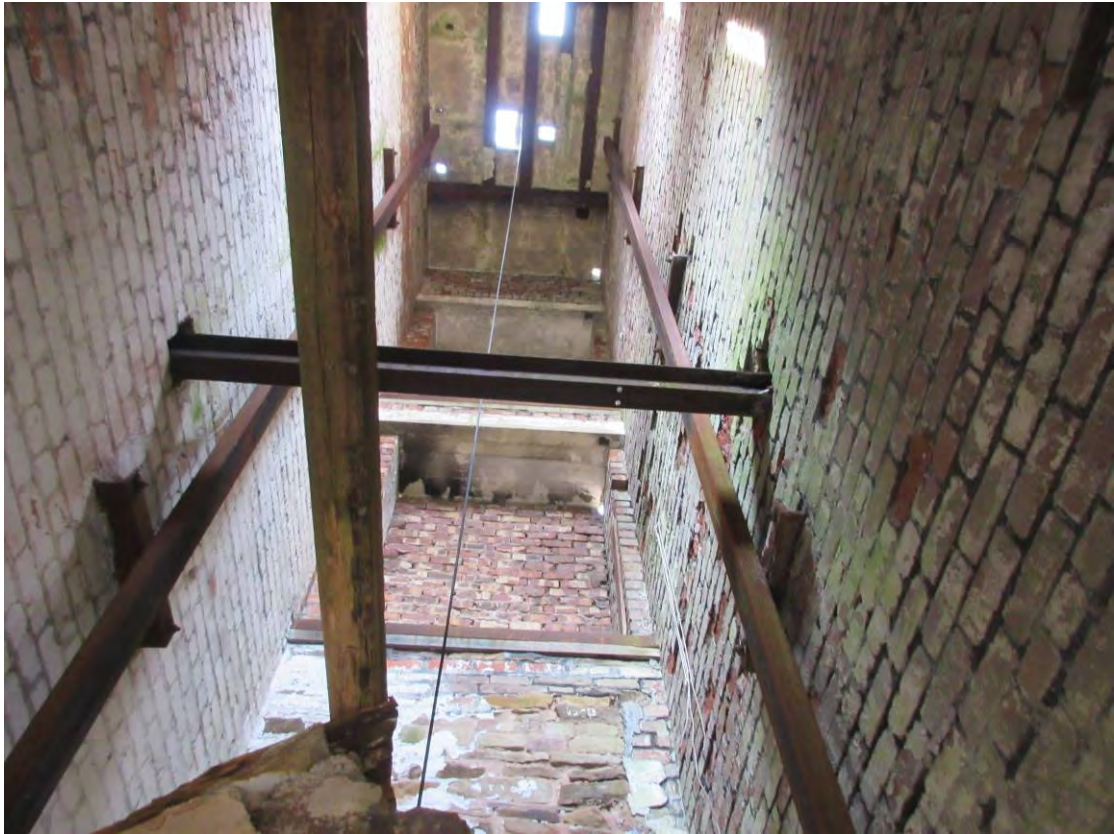
- 2.04 A central outrigger of five stories in height was exhibited together with a more modern outrigger at the East side of the main outrigger. Sections of the roof structure and finishes to the outriggers did remain but were damaged beyond repair and in an unstable condition. Self – seeded trees were noted to be growing at the head of the outriggers and weathering of the head of the outrigger walls was evident. Lateral movement of the structure to the smaller outrigger was noted. The outriggers appeared to be constructed using loadbearing brickwork clad in stone.

A.3 Internal Structure of Central Outrigger to South Elevation

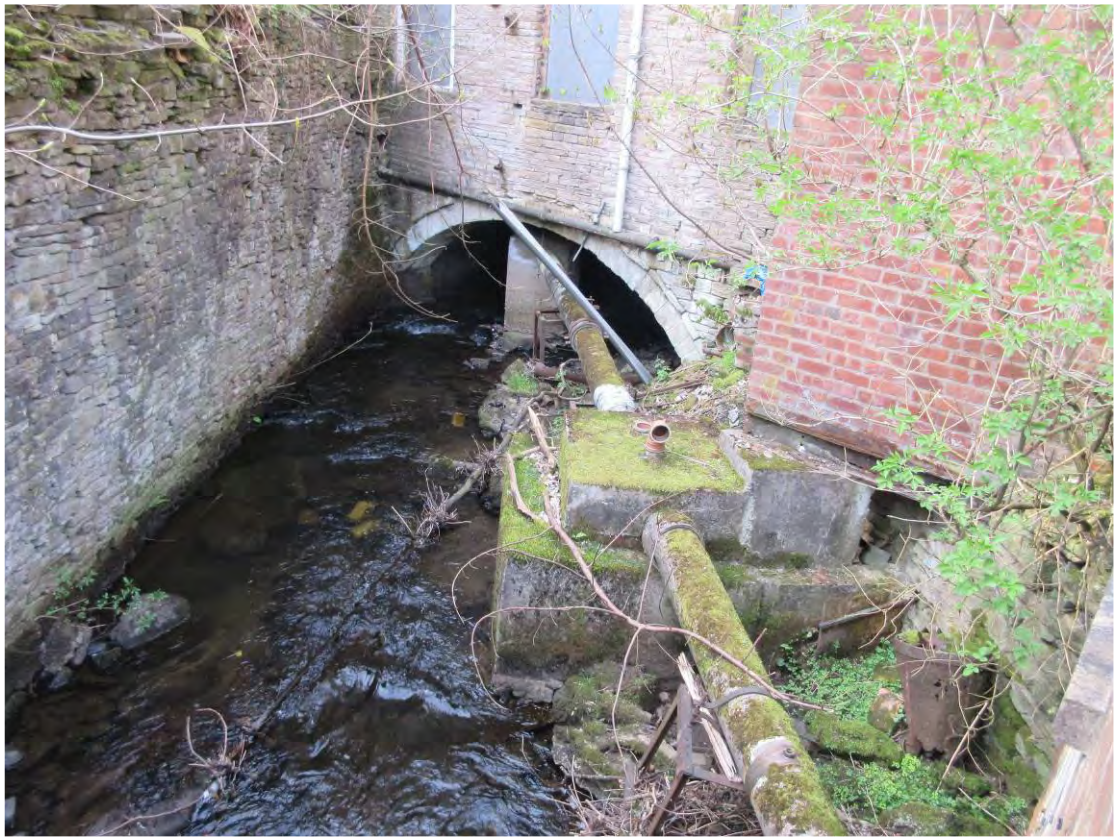
A.4 Masonry Arch Supporting West Side of South Elevation

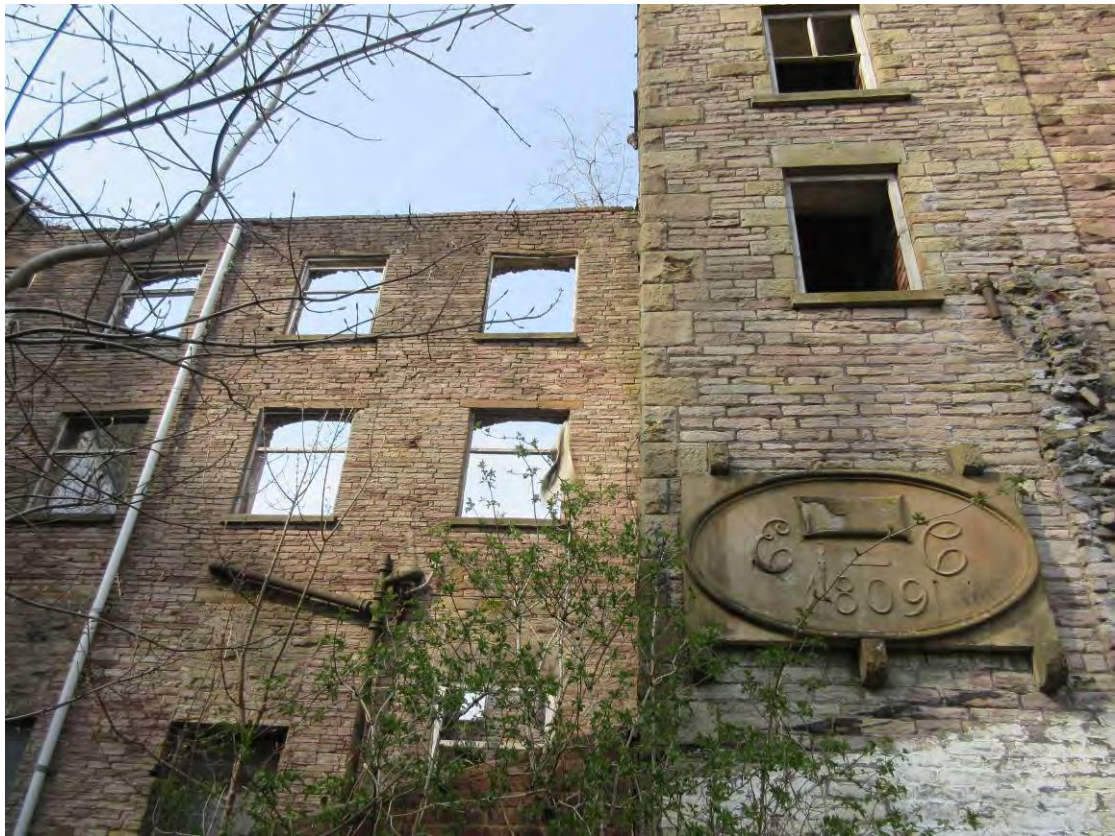
A.5 West Side of South Elevation showing Unstable Stonework

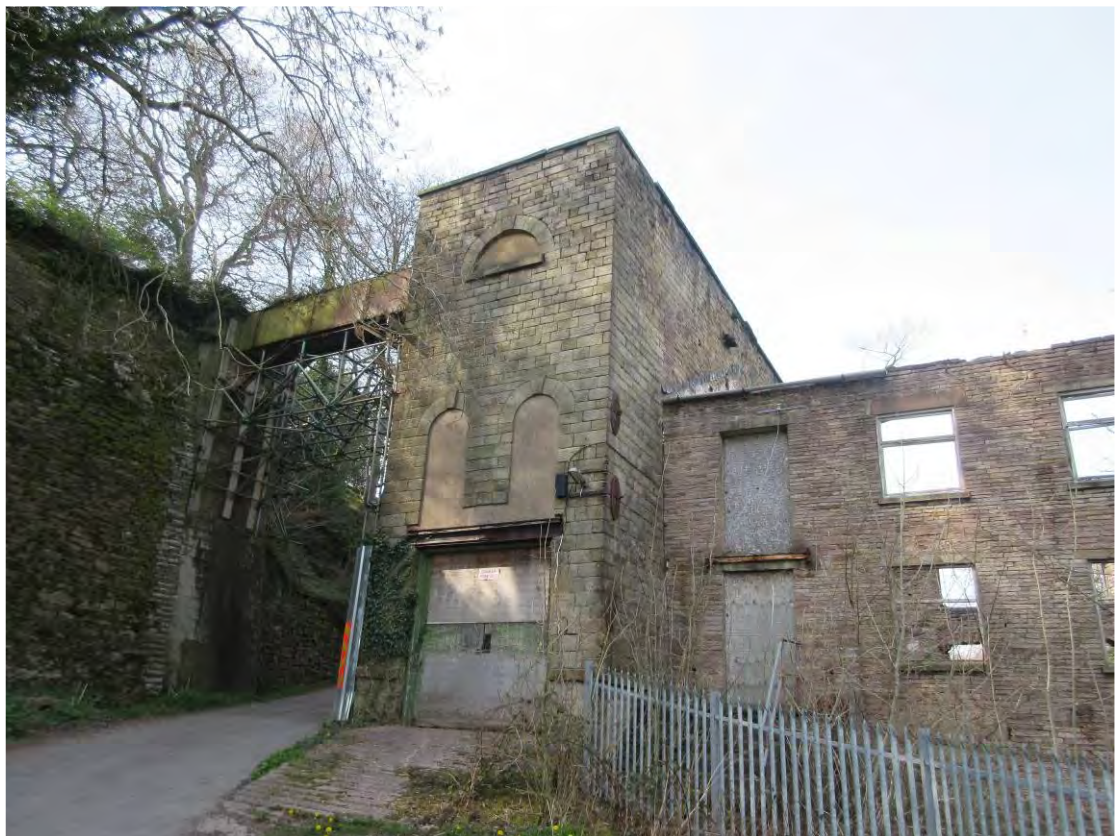
- 2.05 At the West side of the South elevation a water wheel building was present which consisted of a stone rectangular building with a more modern loadbearing brickwork outrigger. The stone section exhibited signs of local deterioration and movement of the stonework but appeared relatively stable. This section of the building exhibited a parapet and damage to the coping stones and parapet was noted in several areas. The roof structure to the outrigger was damaged beyond repair although the main structural walls to the outrigger did not appear to be in poor condition. An aqueduct structure spanned from the adjoining site to the wheel house at high level and temporary propping of the aqueduct had been installed at some point in the relatively recent past.

- 3.02 The wheel house section of the building appeared relatively stable and it is thought this could be safely retained and re-used as part of the development. It is likely the roof structure will need replacing and local stone repairs to the parapet and upper sections of the wall will be required. The retaining wall at the base of the East side of the wheel house adjacent to the watercourse will need to be closely inspected following making safe of the West side of the South elevation as the retaining wall may need some strengthening works or remedial works to ensure the long term stability of the East wall to the wheel house. A detailed assessment of the aqueduct will be required when safe access can be provided and it is likely substantial remedial works will be required in order to make good the aqueduct structure and maintain the structural stability of the aqueduct in the future.

A.6 Wheel House at West Side of South Elevation

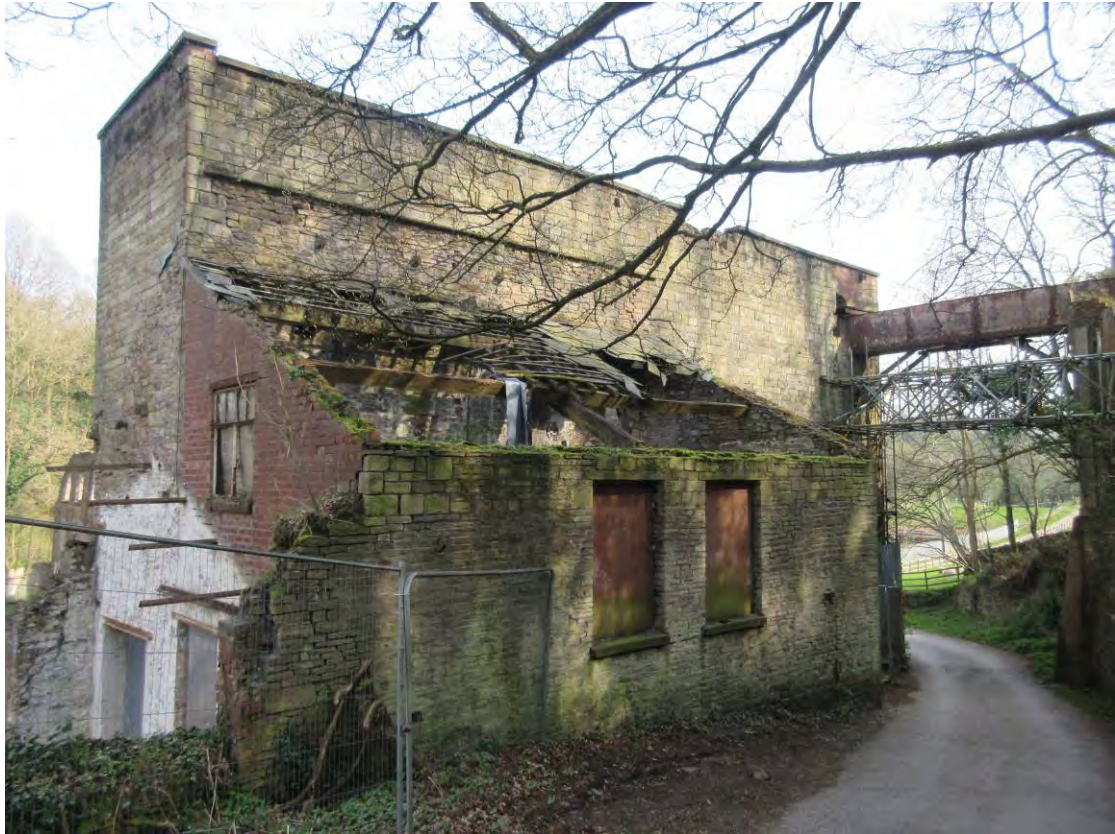
A.7 West Elevation of Wheel House Showing Aqueduct

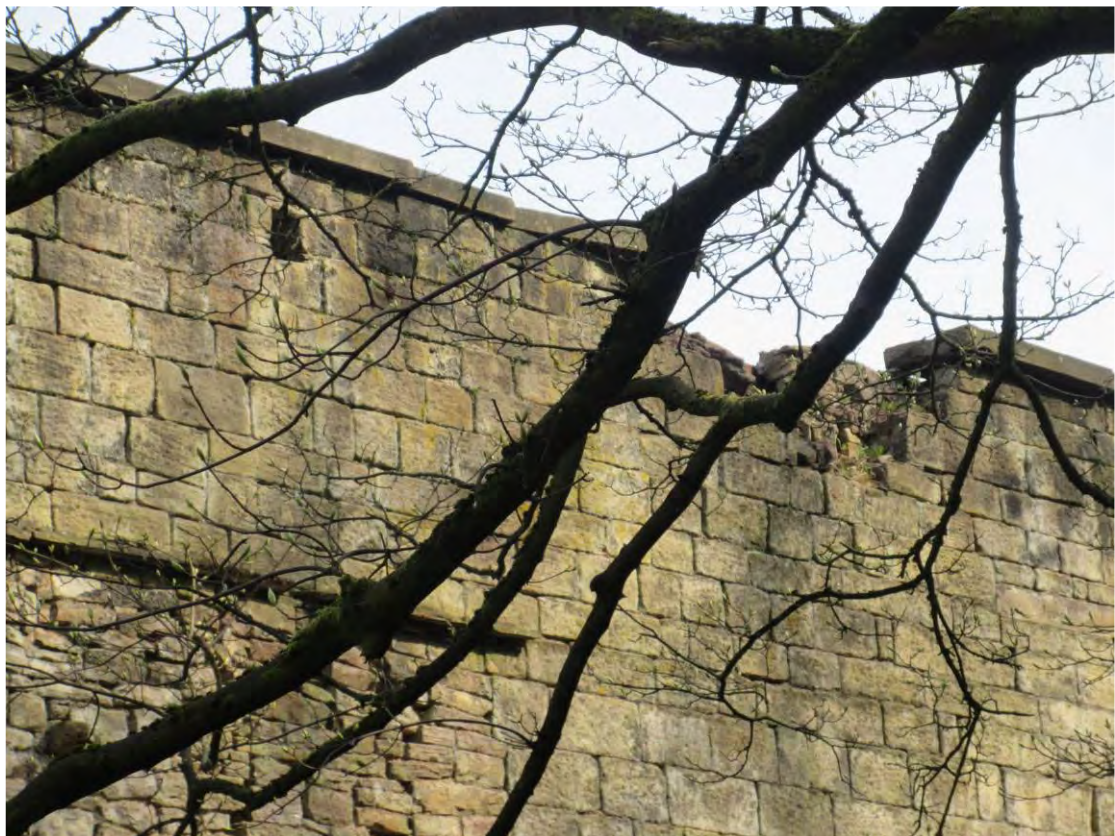
A.8 Local Damage to Parapet of Wheel House

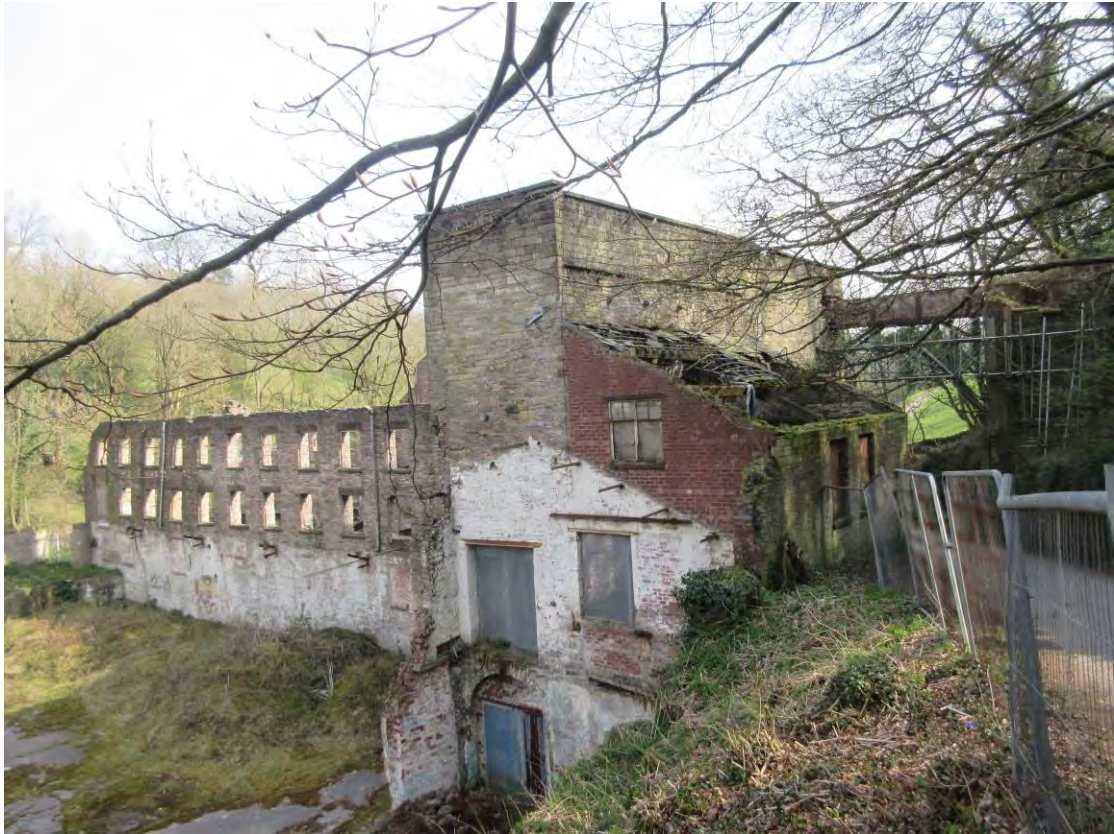
- 2.06 The North elevation was of a similar form to the South elevation and exhibited a significant lateral movement at the East side of the elevation. Further signs of local movement of the stone structure and weathering of the exposed head of the wall were noted throughout the elevation. The remains of what are thought to be steel roof trusses from a previous adjoining building were noted

A.9 North Elevation of Building

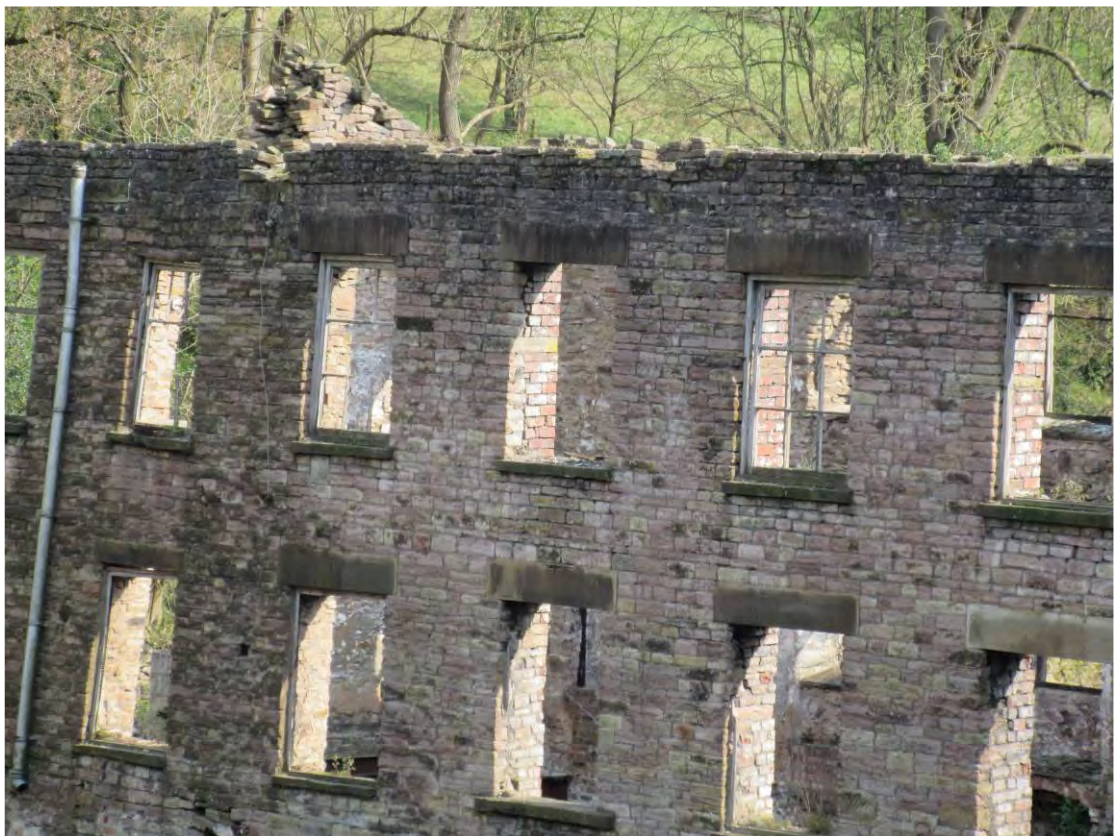
A.10 Damage to Head of North Elevation Wall

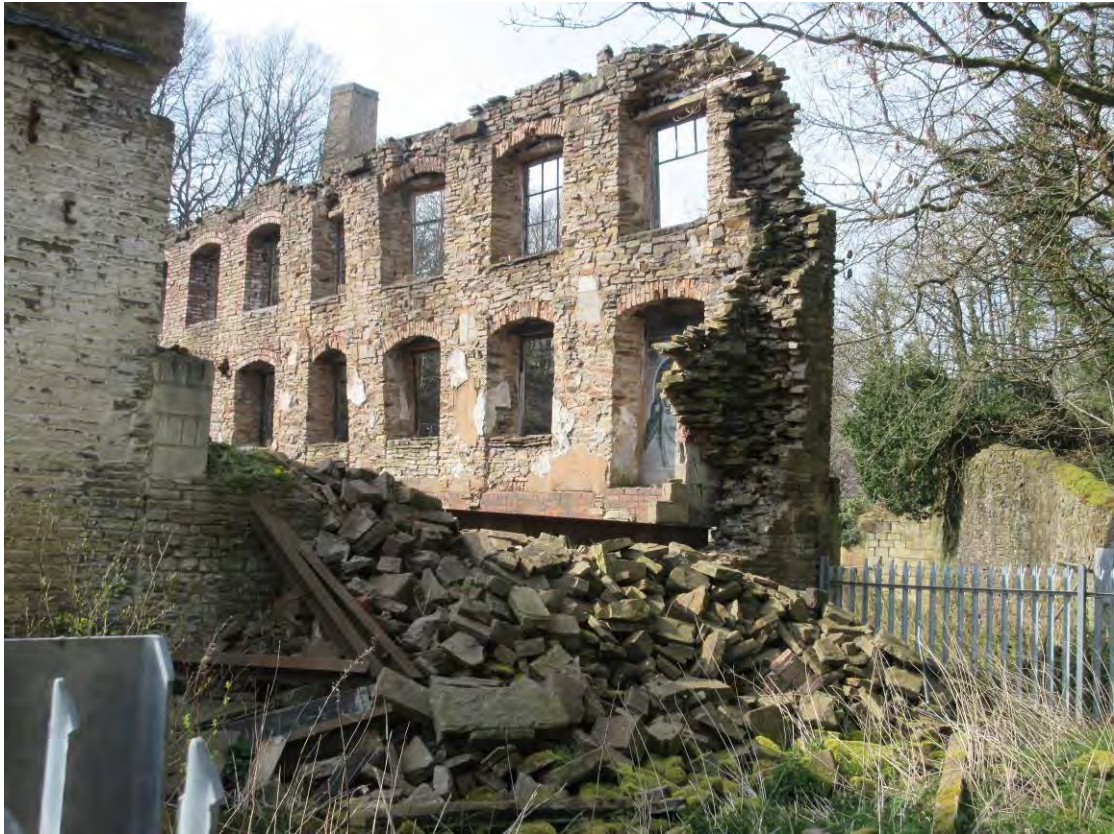
- 2.07 The majority of the East gable wall had collapsed and only a small section of the gable wall adjacent to the South elevation remained. This section of wall exhibited signs of significant structural movement within the stone structure.

A.11 Remains of East Gable

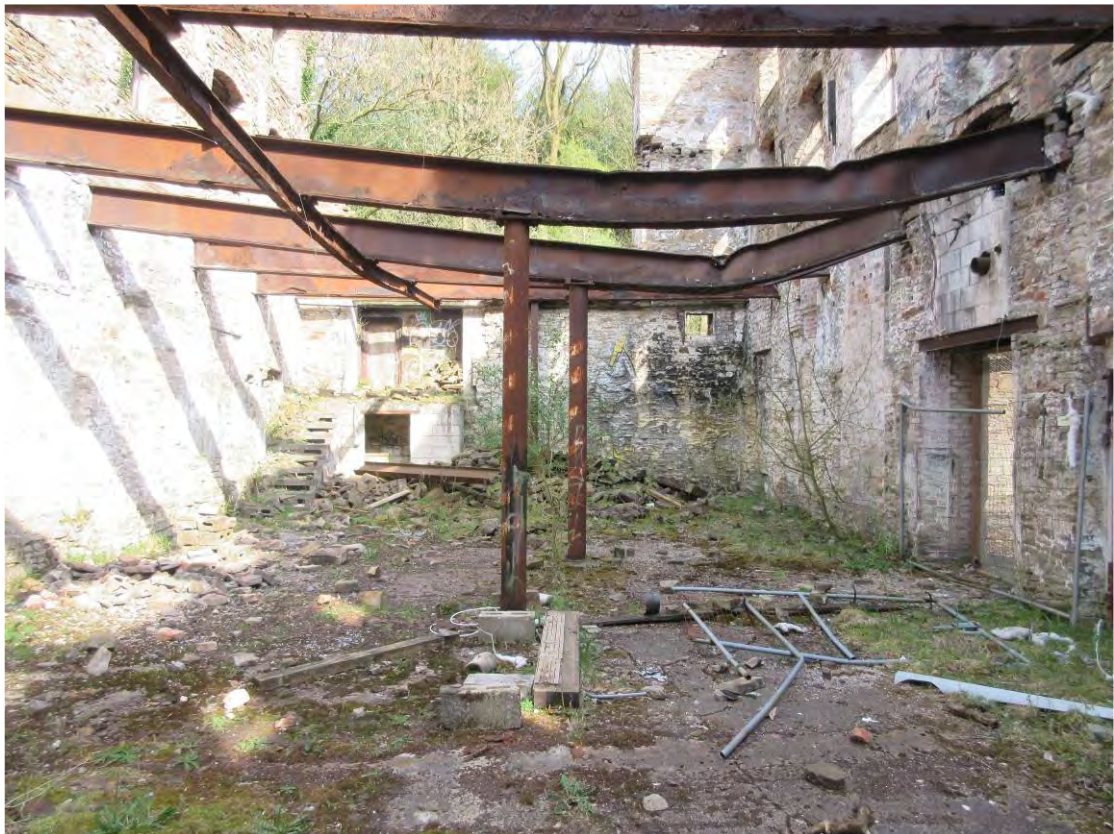
- 2.08 An internal inspection of the main building was undertaken and it was clear the roof and suspended floors had collapsed at some point in the relatively distant past. A grillage of steel support beams were noted at first floor level and the beams were found to be deformed significantly at the East side of the building. The internal faces of the walls which remained and the heads of the walls appeared very heavily weathered and signs of local and global instabilities were noted throughout. Brick arches were exhibited internally over the heads of a number of the window openings and loss of mortar and movement of the brick arch structures was evident. Fire damaged sections of timber were noted built into the internal faces of the North and South elevation walls.

A.12 Damaged First Floor Steel Support Beams

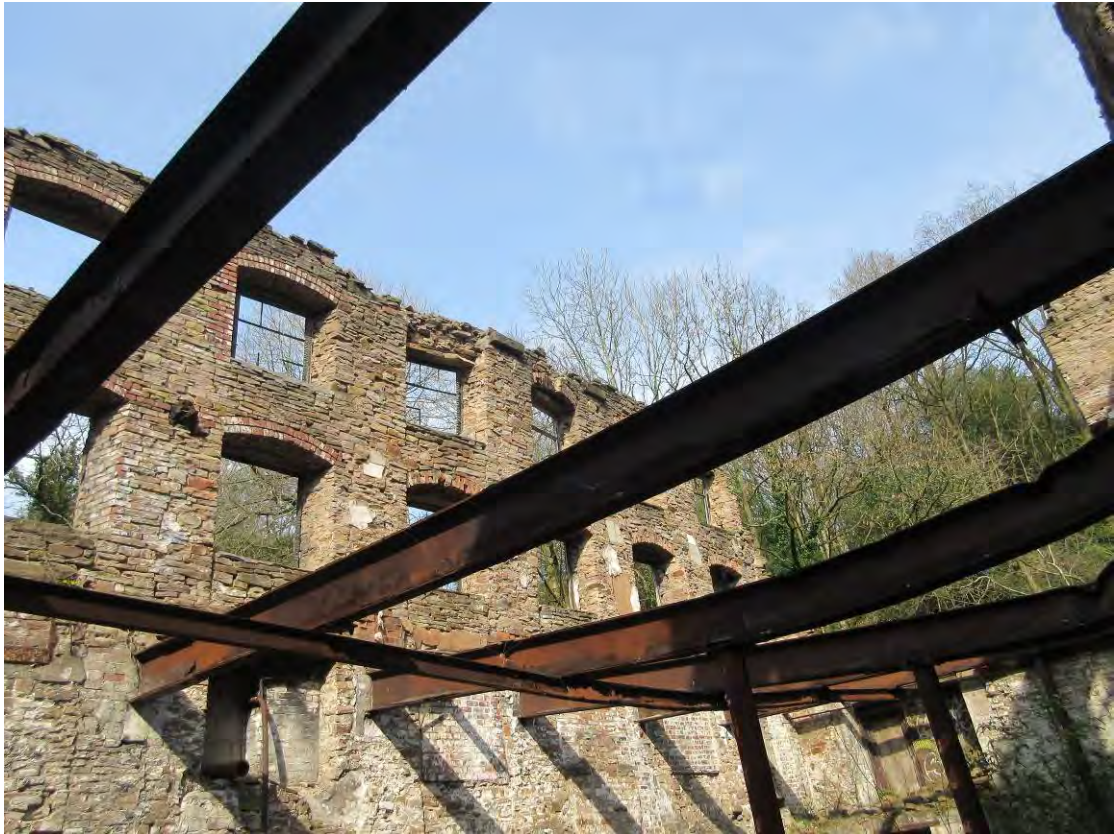
A.13 Movement and Damage to North Elevation Wall

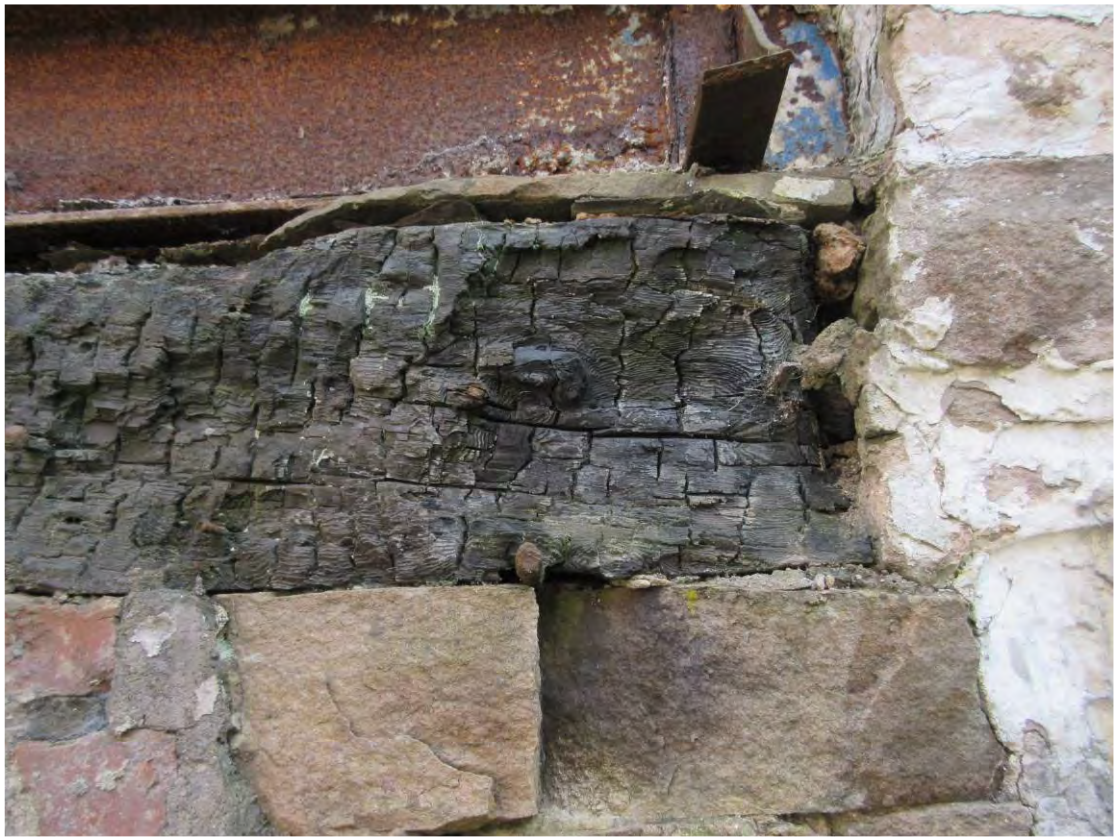
A.14 Fire Damaged Timber Built Into South Elevation Wall
