# Appendix 5: 19/2624M

## Contents

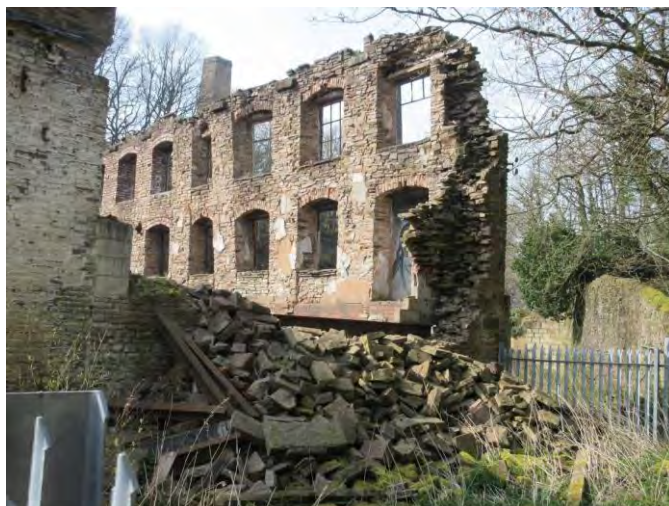
Emery Planning project number: 18-395

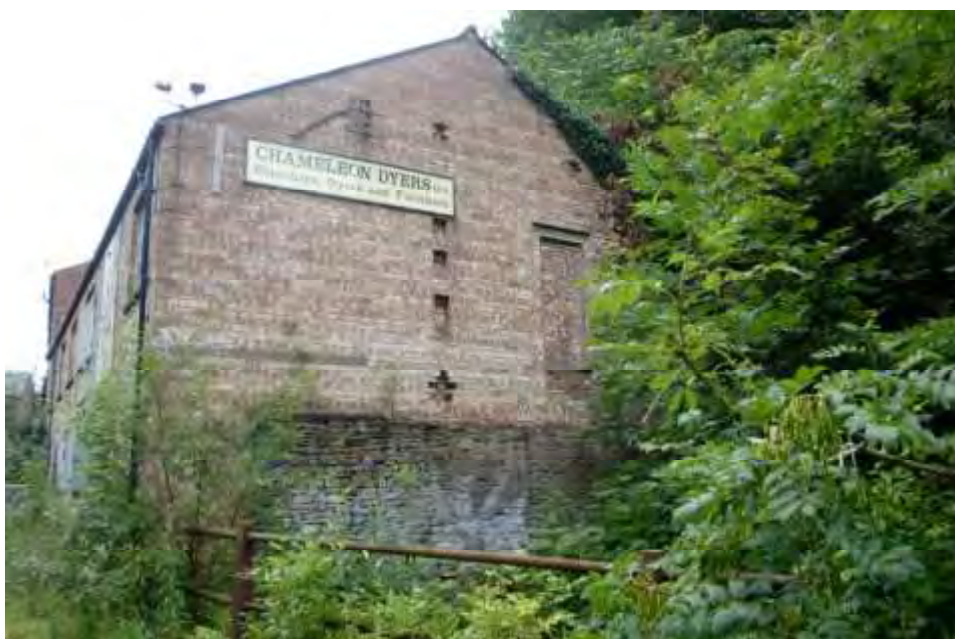
Plate 1: North elevation of Building A, with earlier stone footings at lower level

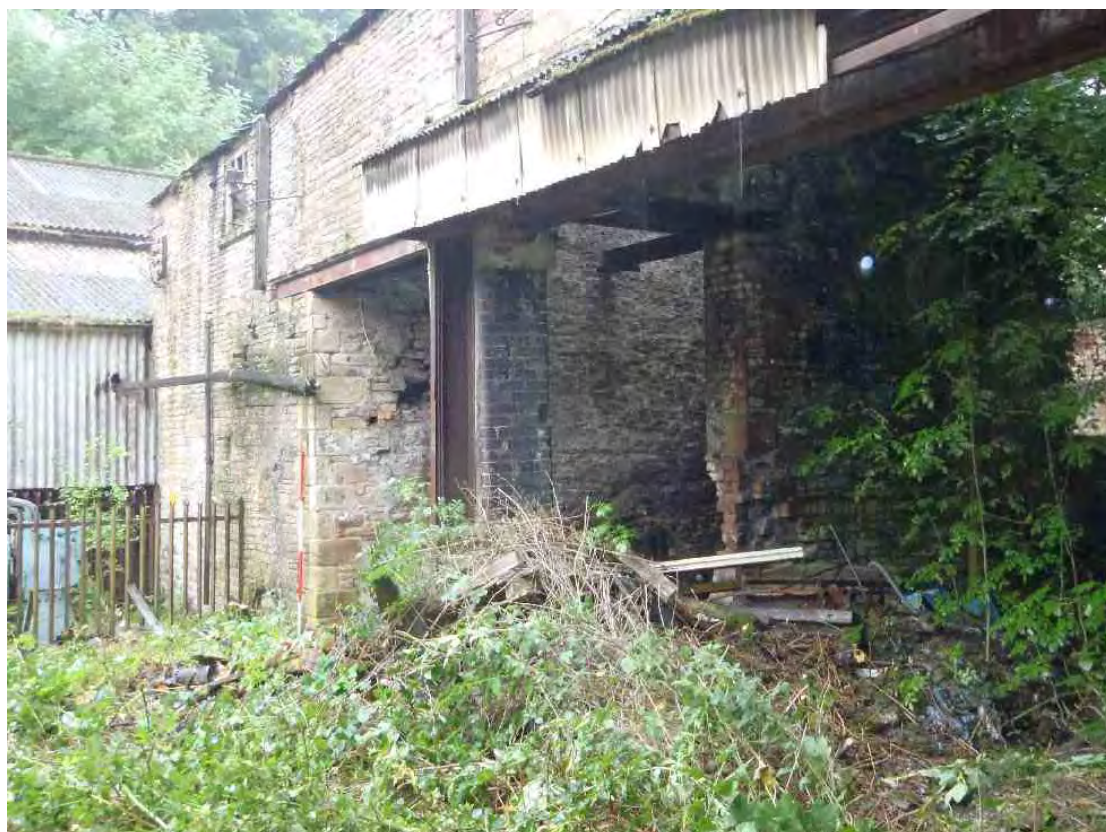
*Plate 8: Open frontage of boiler house in eastern part of Building E*

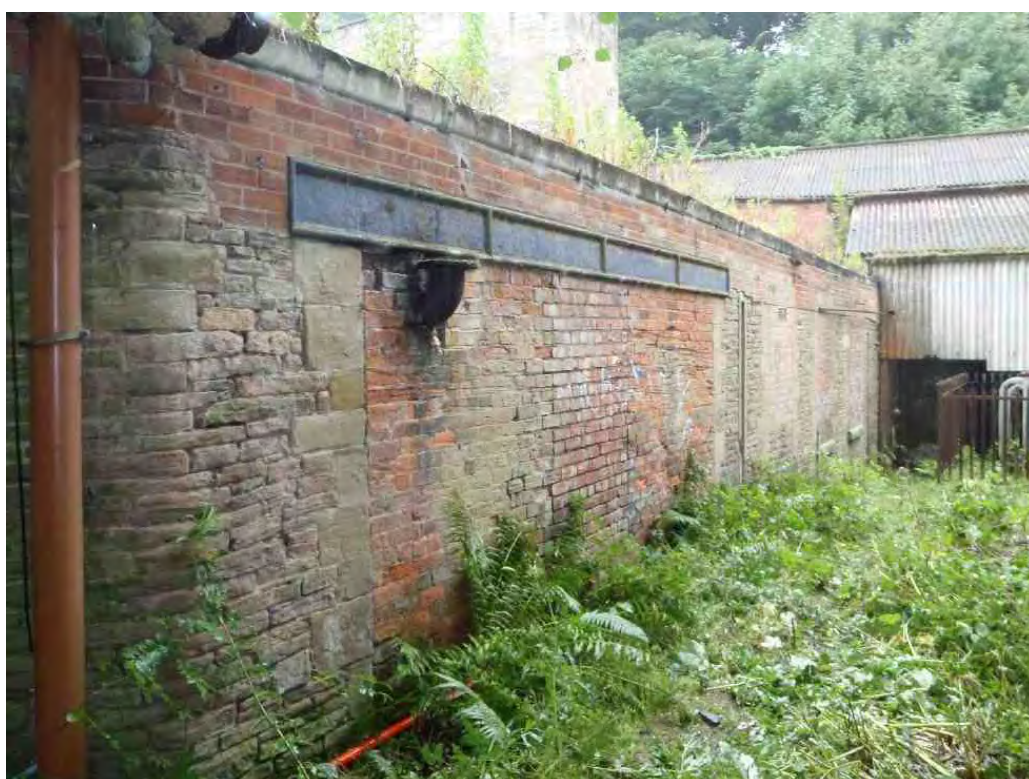
Plate 9: North elevation of Building F, with blocked apertures and rebuilt wall-head

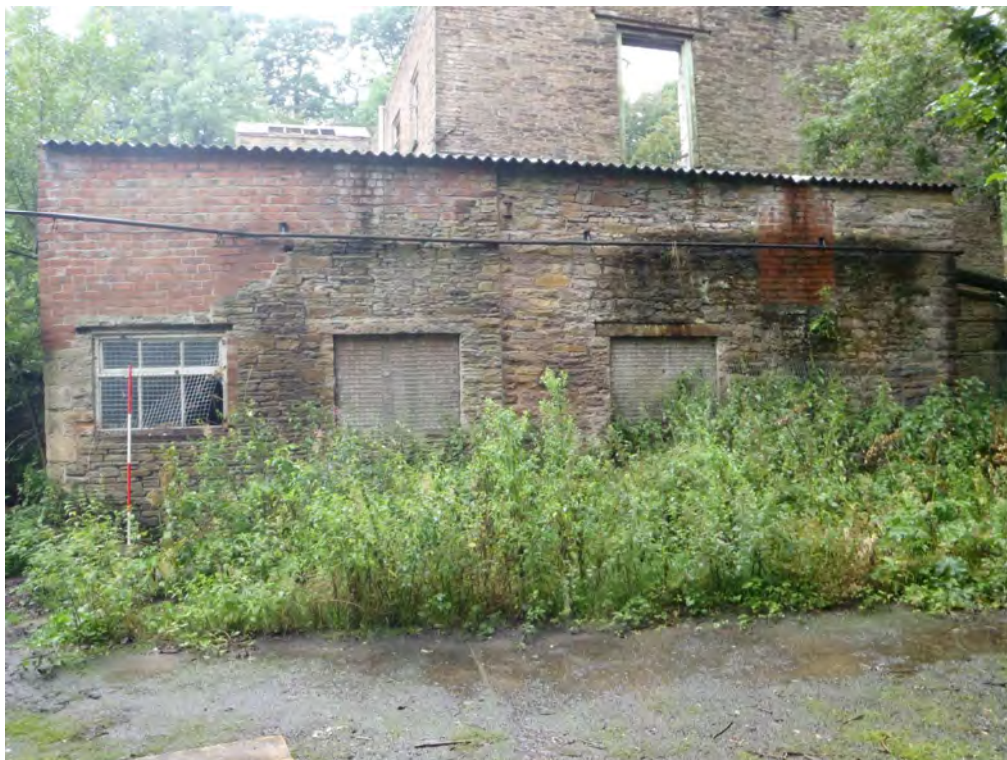
Plate 12: East elevation of Building L, with central butt-joint within stone construction

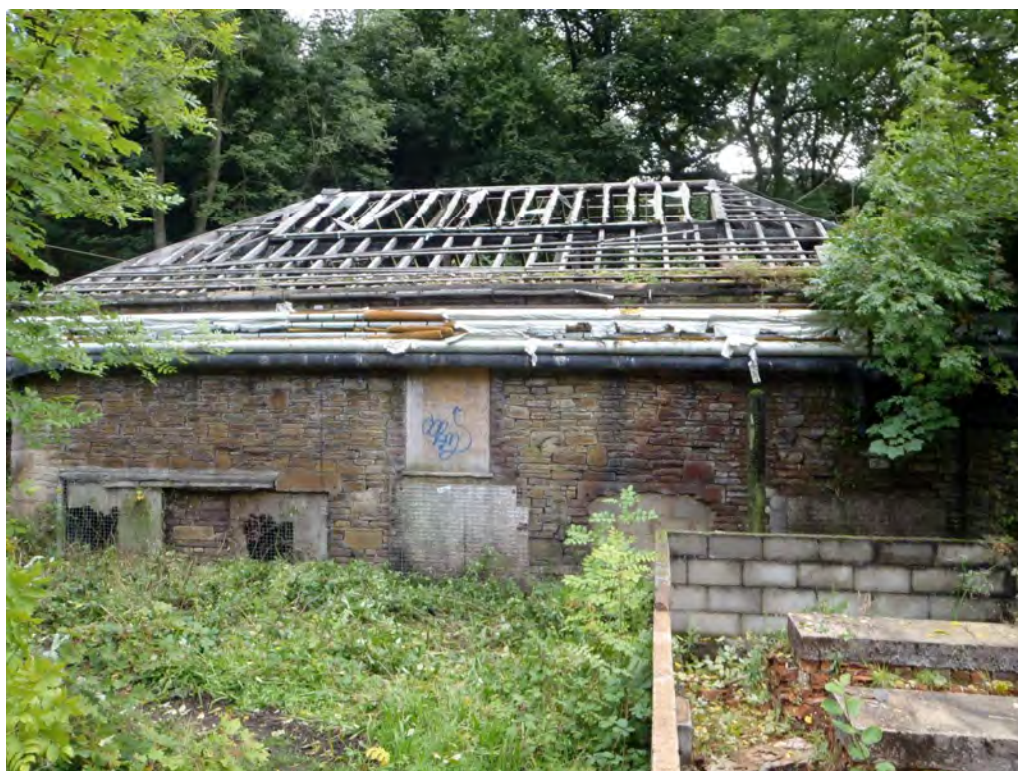
Plate 13: Front elevation of Building P, with raised ground level in the foreground

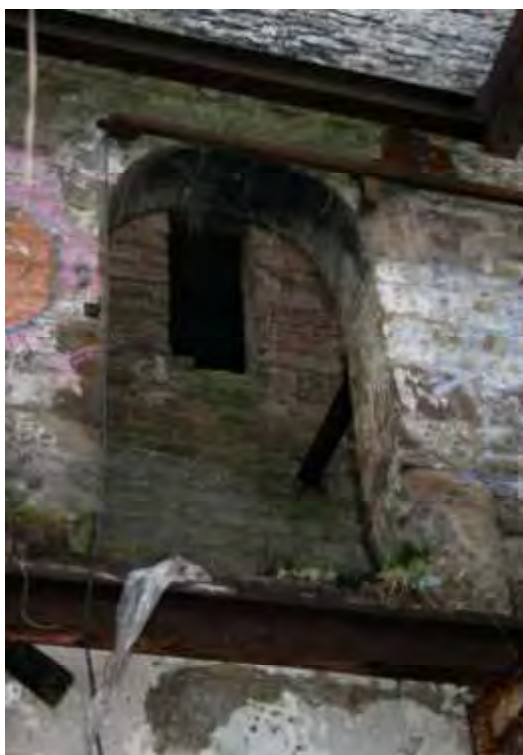
*Plate 22: Detail of axle mount for water wheel, with cut padstone*

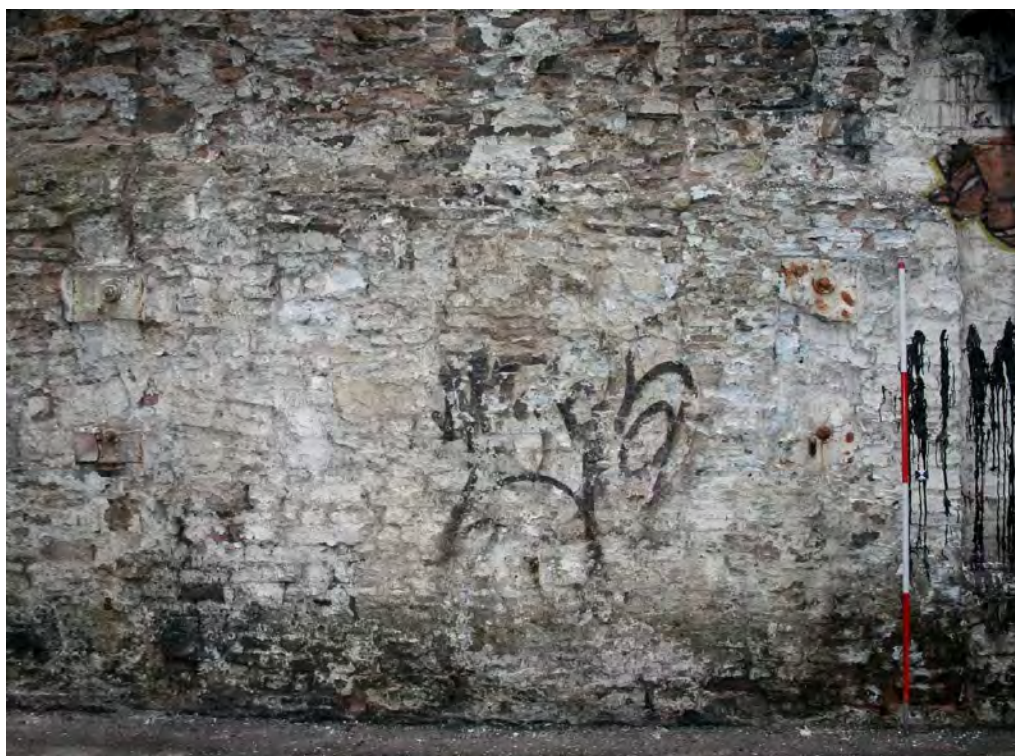
*Plate 23: Broken cast-iron wall brackets, north elevation, Building I*

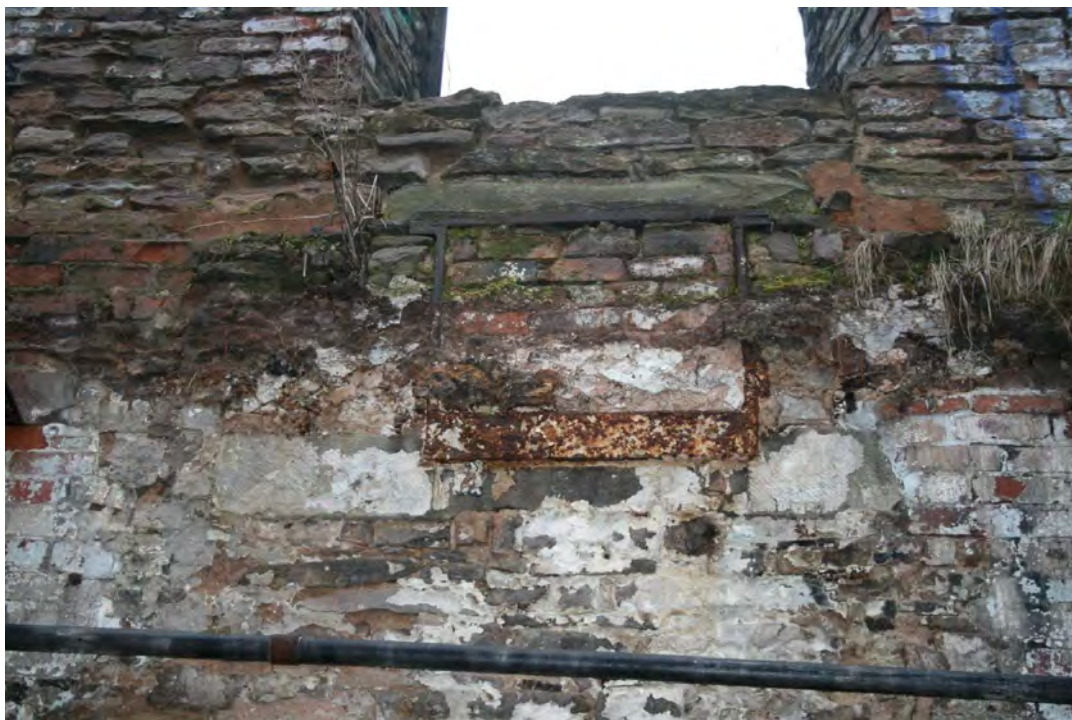
*Plate 24: Large cast-iron bearing box, Bay 7, Building I, flanked by smaller apertures*

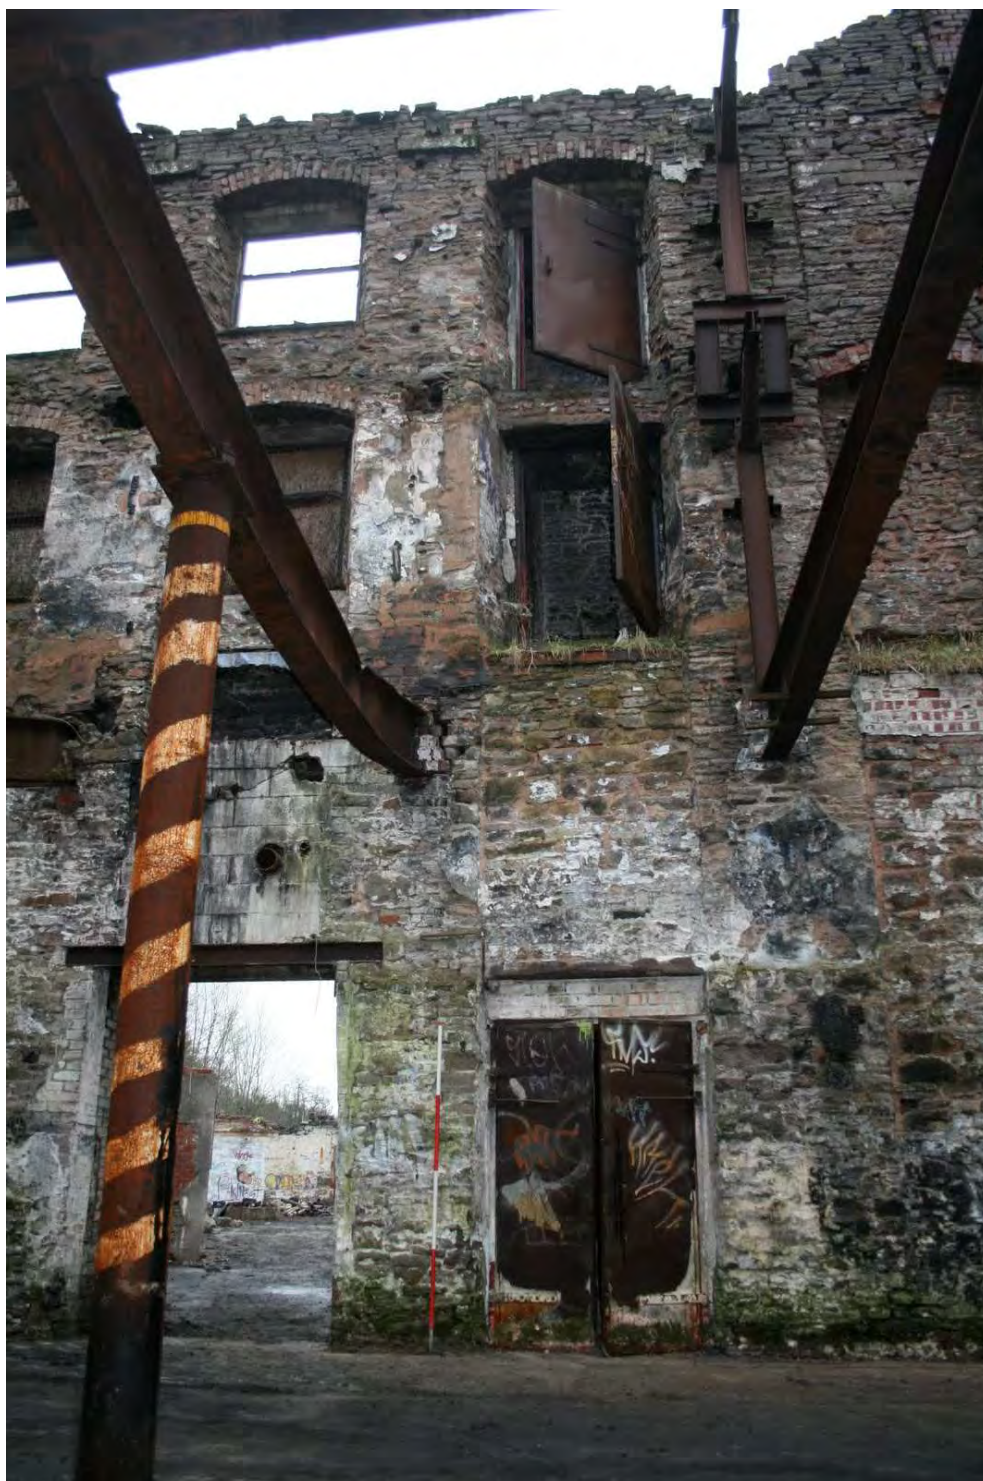
Plate 28: Bay 8, south elevation, Building I, showing doorways into stair tower J

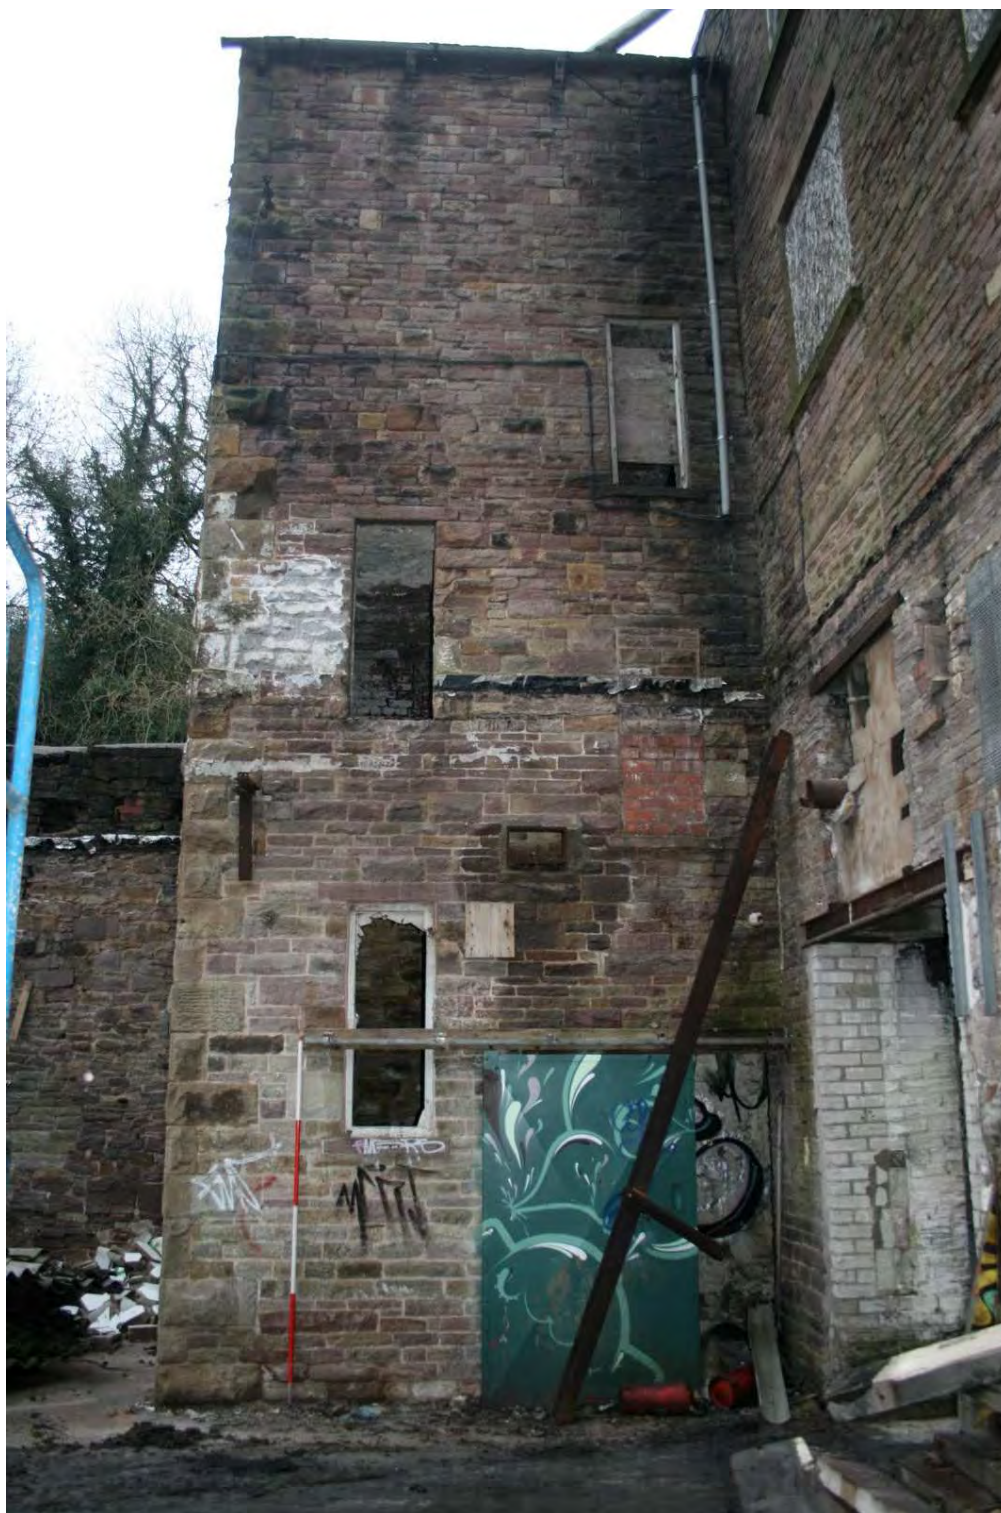
Plate 29: East wall of stair tower with landing windows and two inserted bearing boxes

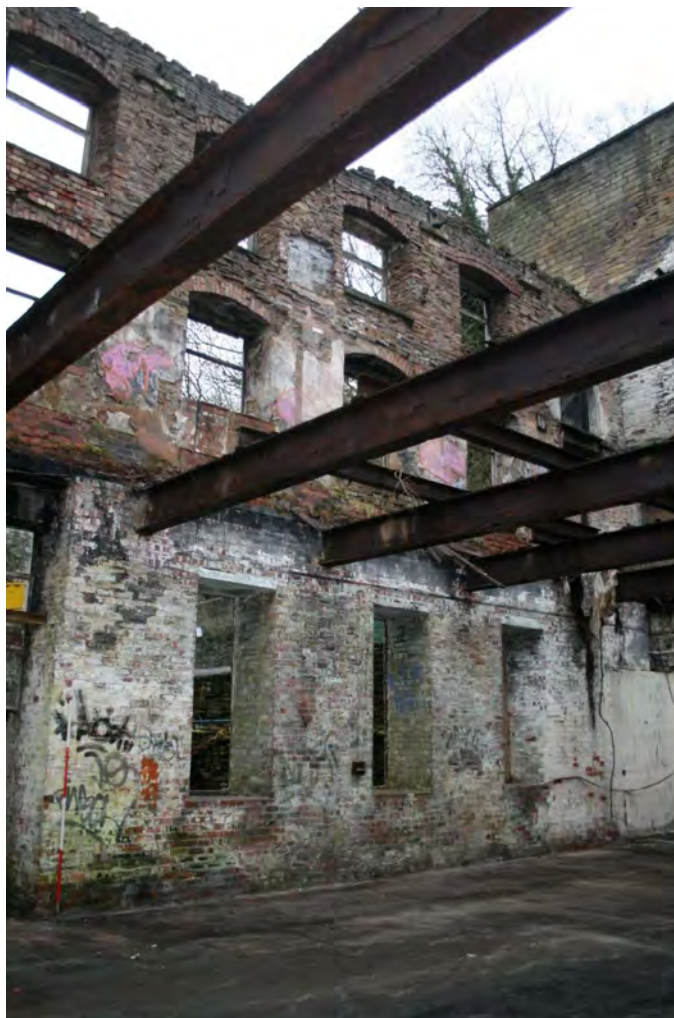
*Plate 32: Western bays of south elevation, Building I, showing refaced ground floor*

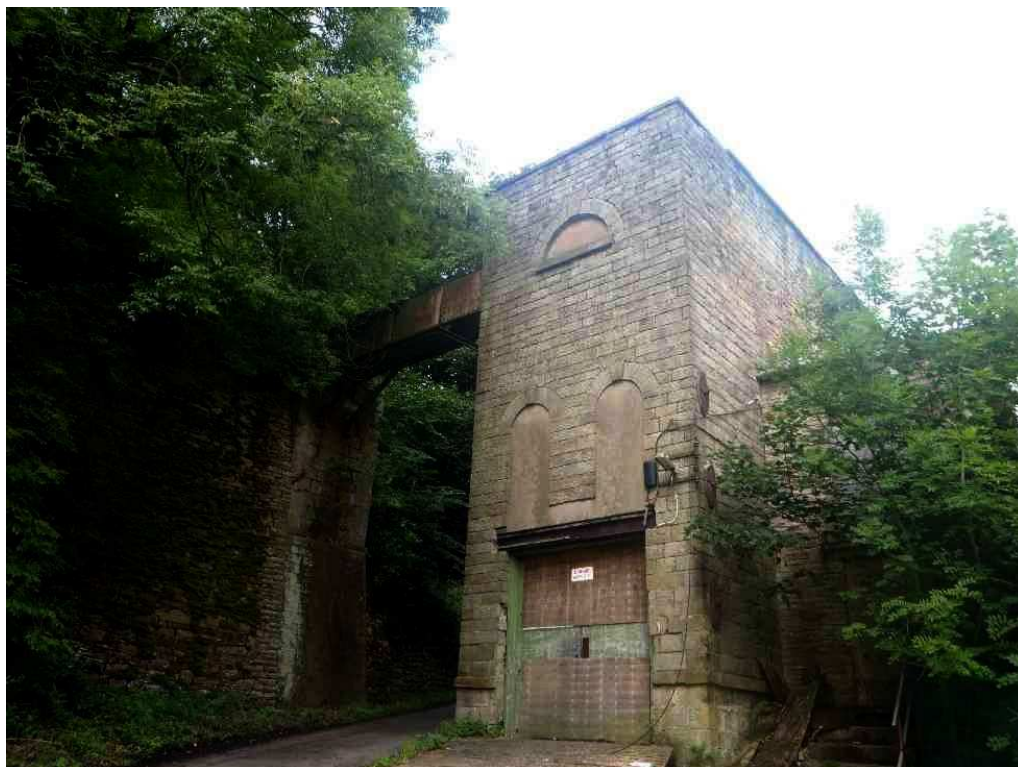
*Plate 33: Large 1850s wheel house, with cast iron trough supplying water from a reservoir*

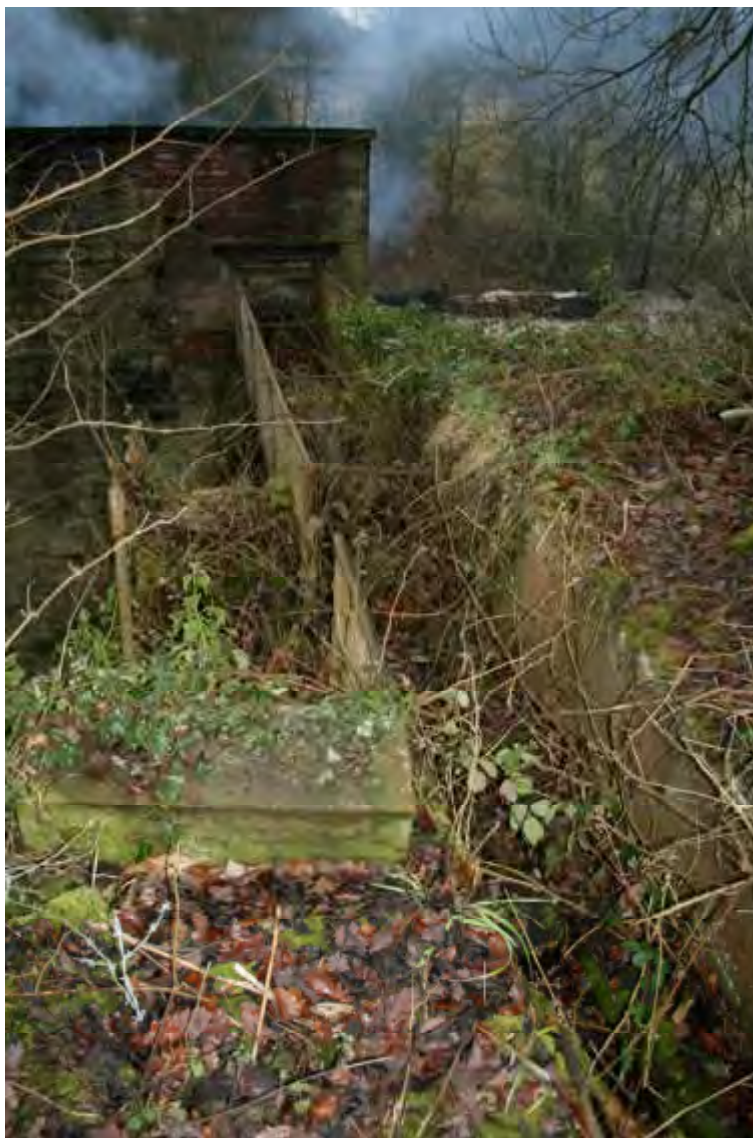
Plate 34: Detail of iron-sheet trough from reservoir into wheel house

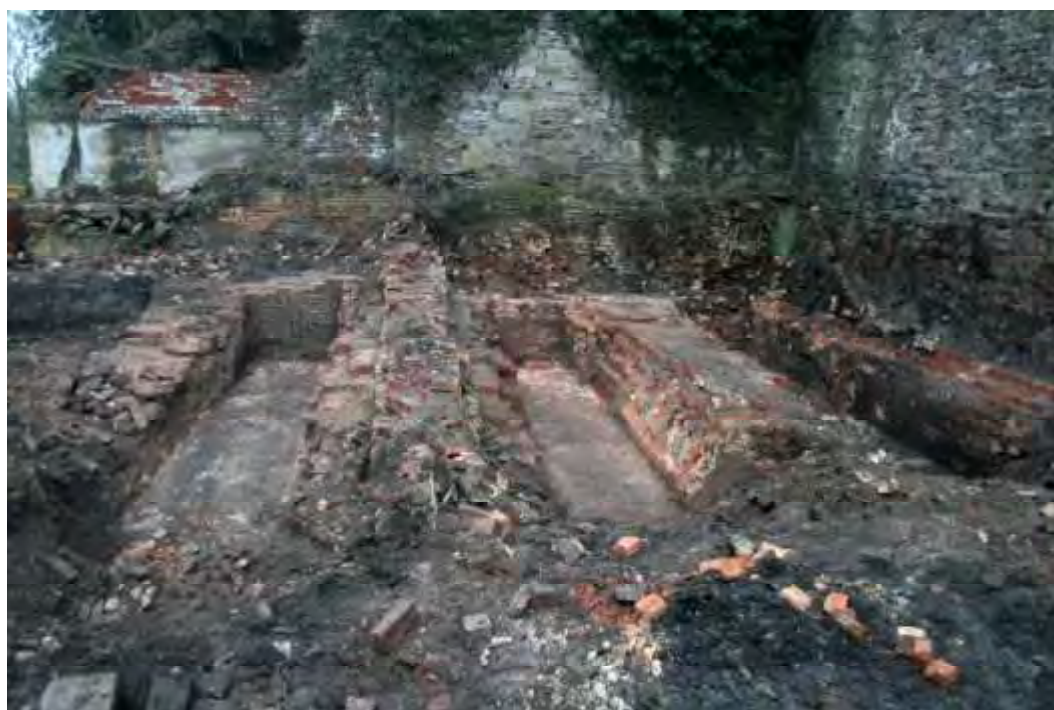
*Plate 36: Three boiler beds with partially intact benches observed below Building E*

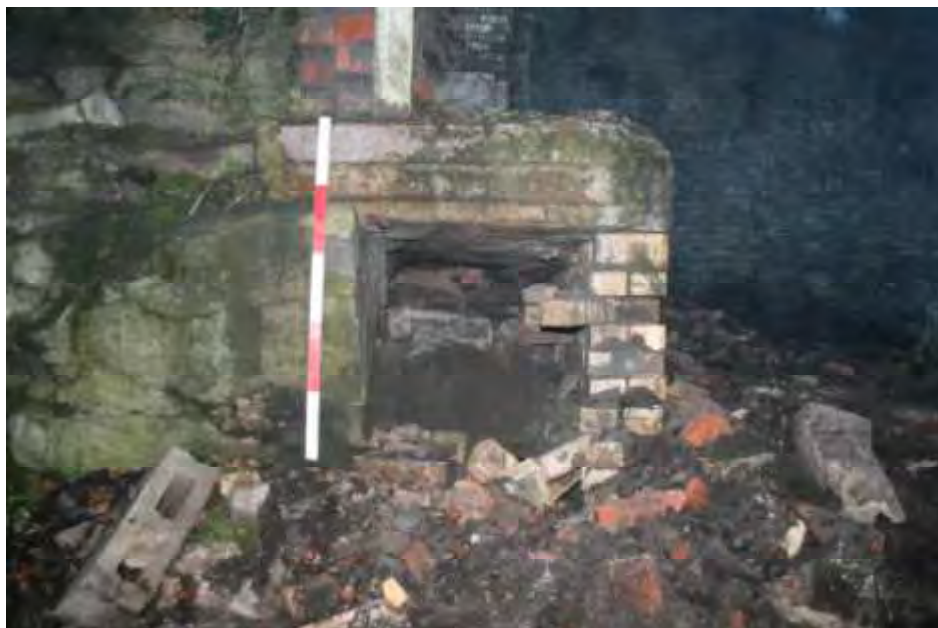
*Plate 37: Flue on boiler bench, and at rear (right) of both visible beds into main flue*

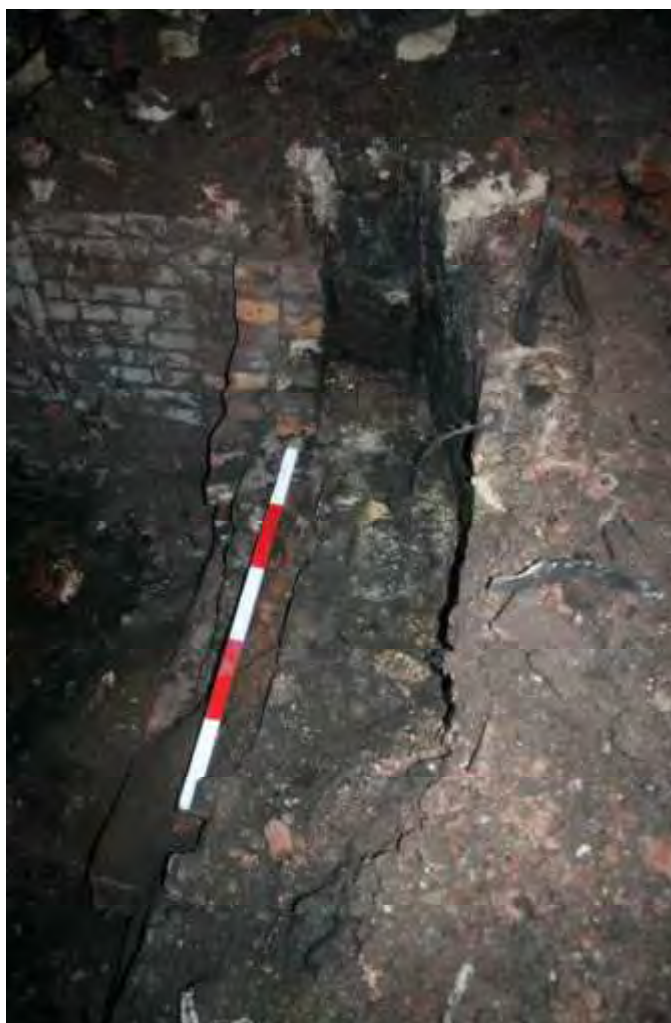
Plate 39: Boiler flue adjacent to front edge of Building E

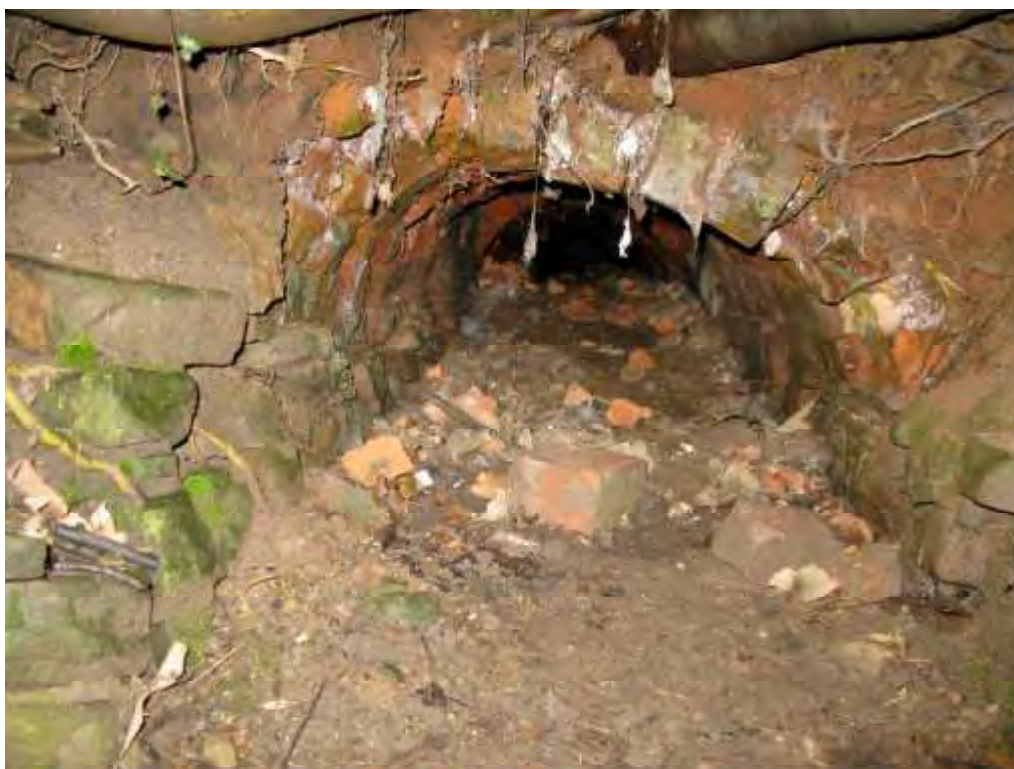
Plate 40: Extant section of flue from boilers within Building E to demolished chimney above

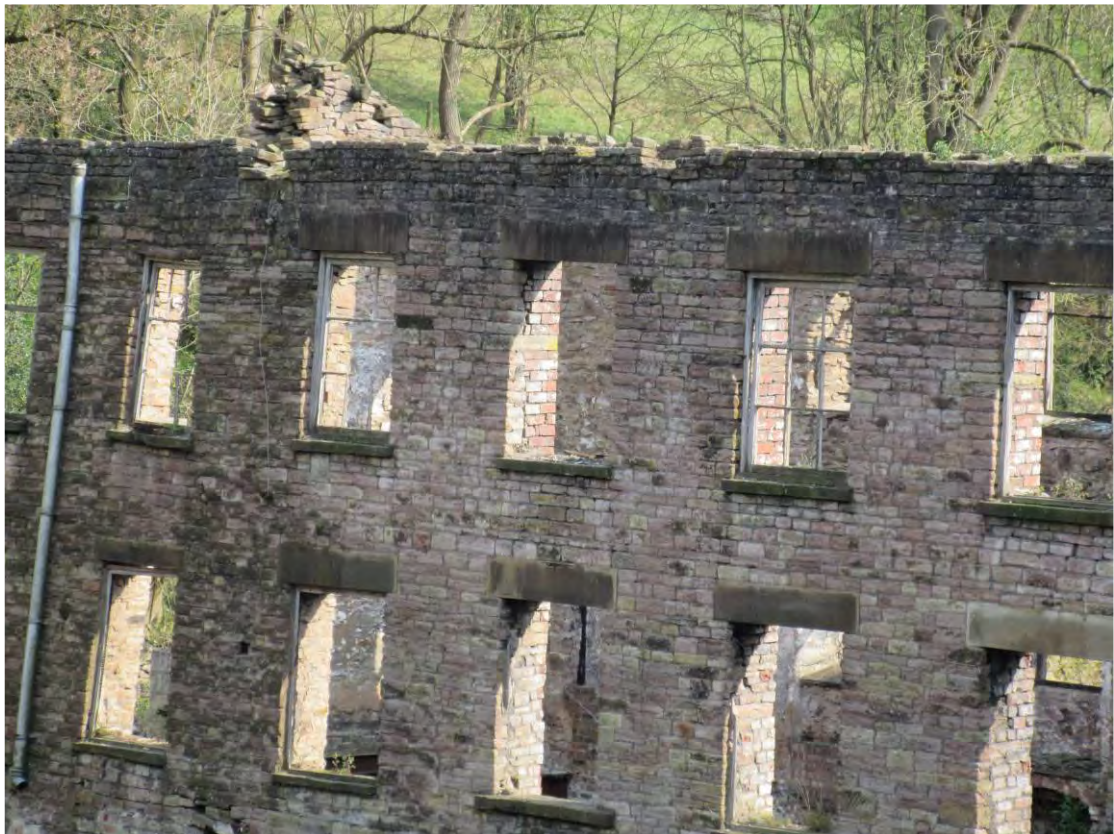
A.10 Damage to Head of North Elevation Wall

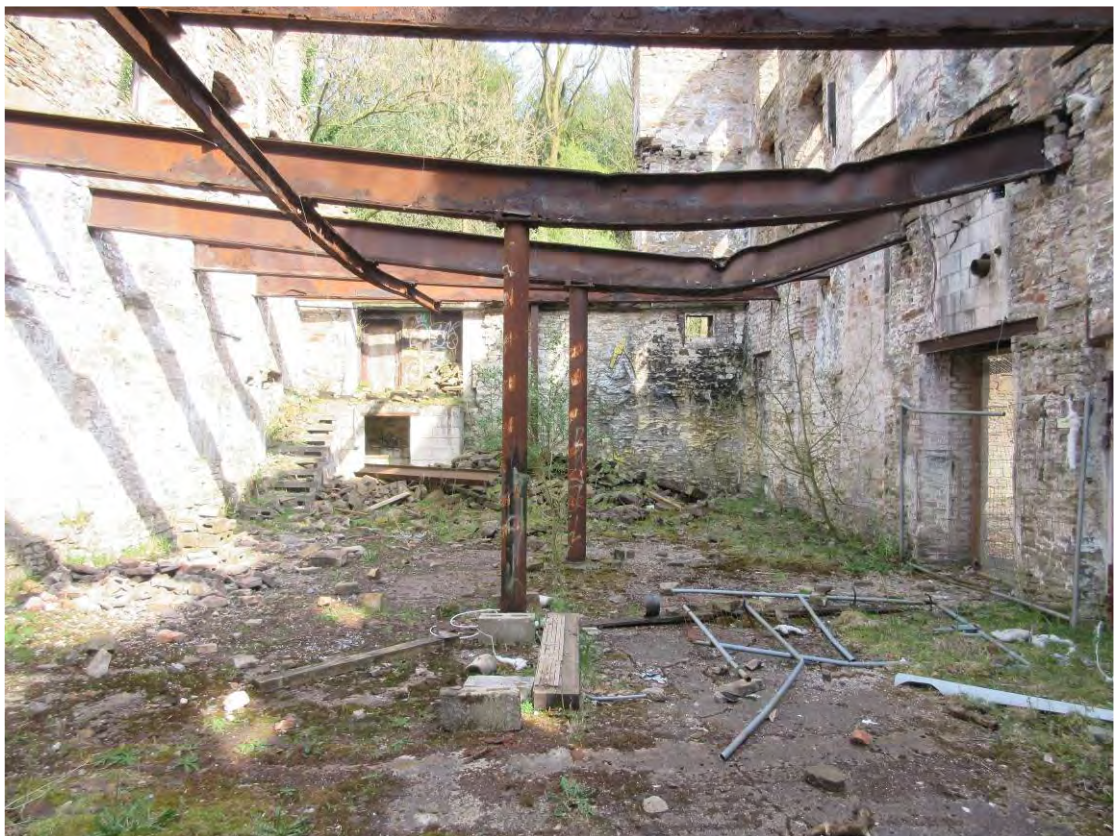
A.12 Damaged First Floor Steel Support Beams
